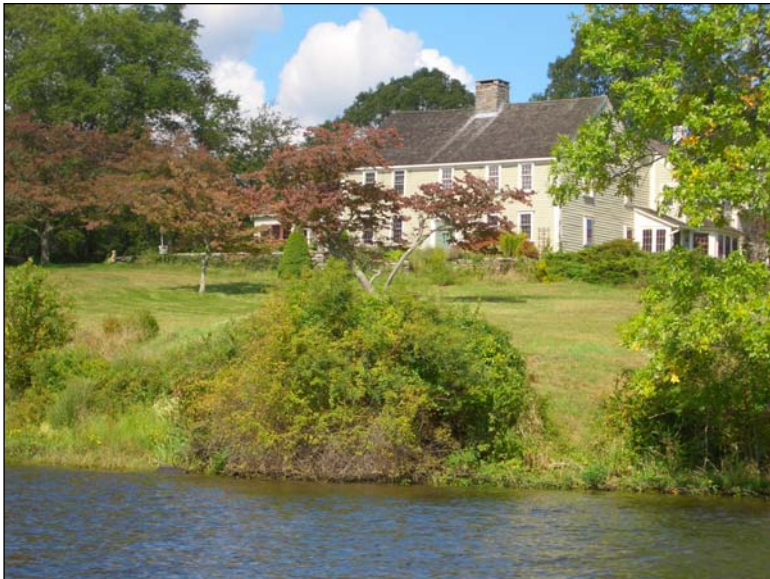
A reasonable buffer could be enhanced and created in areas where a sloping lawn reaches to the waterfront.

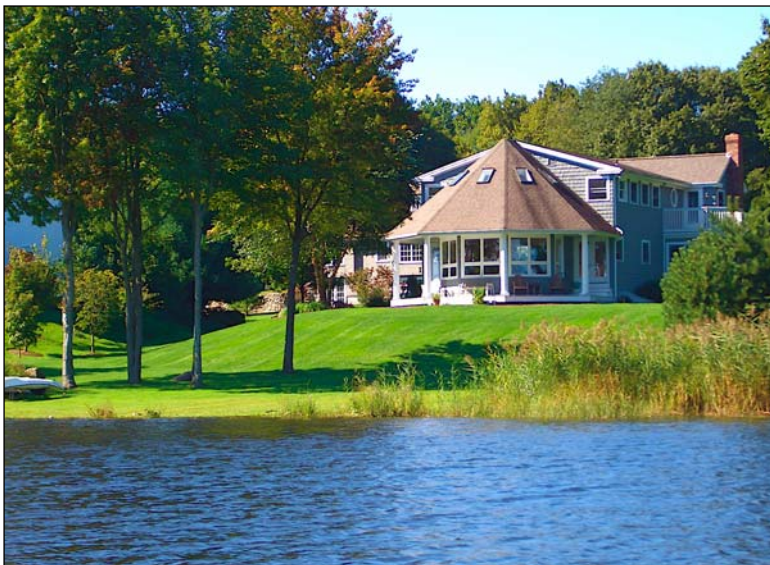
This maintained lawn slopes directly to the water without benefit of a riparian buffer to prevent fertilizer or other chemicals from entering the water. Even a modest buffer of native plants could provide protection here.

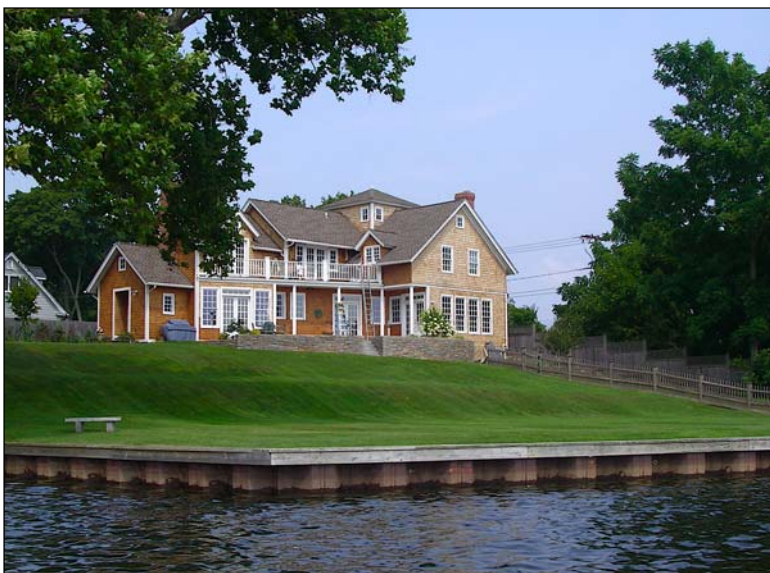
This waterfront that has been modified from a natural shoreline to an engineered retaining wall and is backed by a sloping, maintained lawn. There is little, if any, opportunity for vegetation to remediate chemicals associated with turf management at this site.
